EAGLE LAKE DAM

MA 00979

PHASE I INSPECTION REPORT  
NATIONAL DAM INSPECTION PROGRAM

Identification No.: MA 00979  
Name of Dam: Eagle Lake Dam  
Town: Holden, Massachusetts  
County and State: Worcester County, Massachusetts  
Stream: Asnebumskit Brook  
Date of Inspection: June 13, 1978

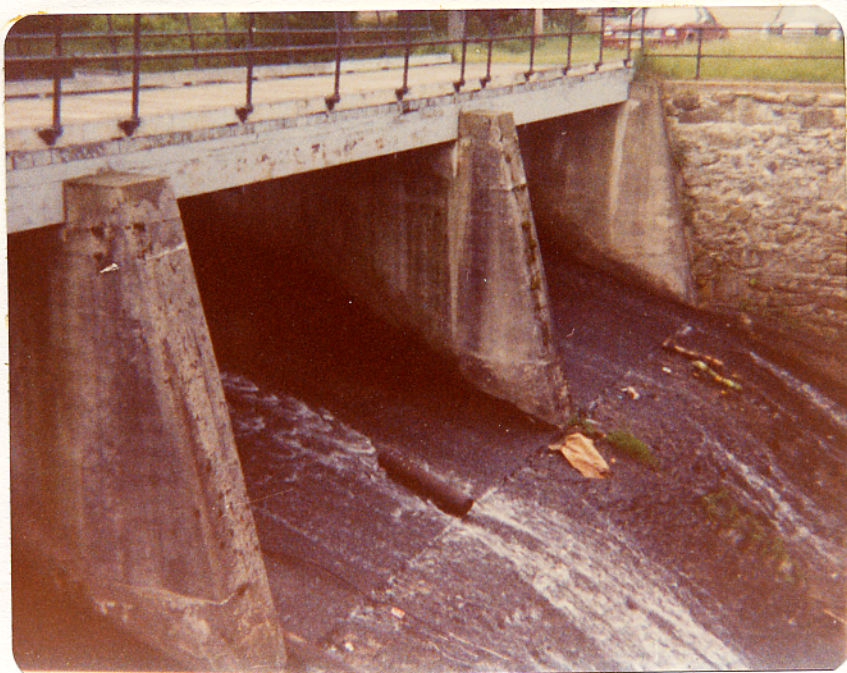
4

Downstream View of Spillway  
from Right Bank

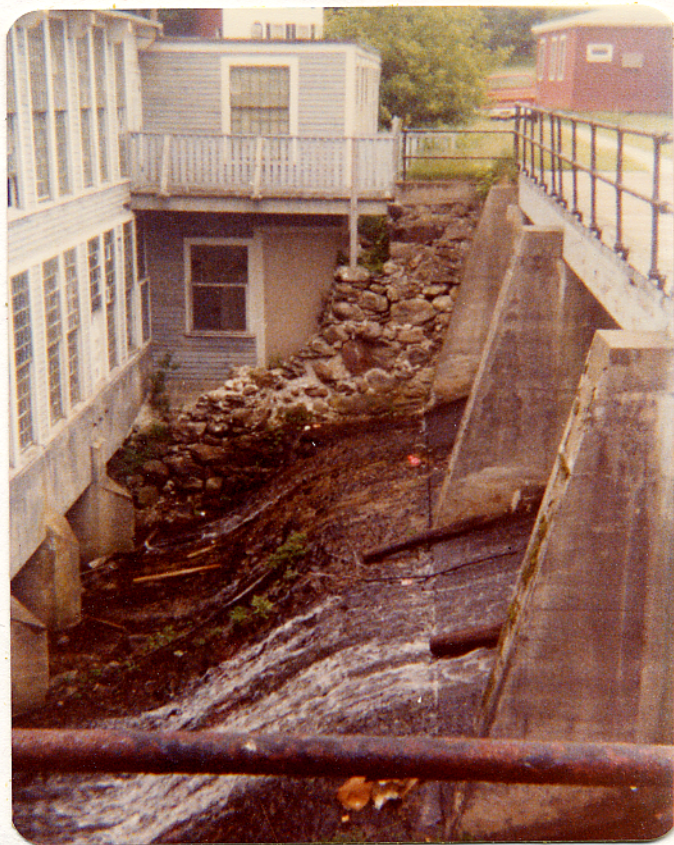
5

Downstream View of Spillway  
from Left Bank

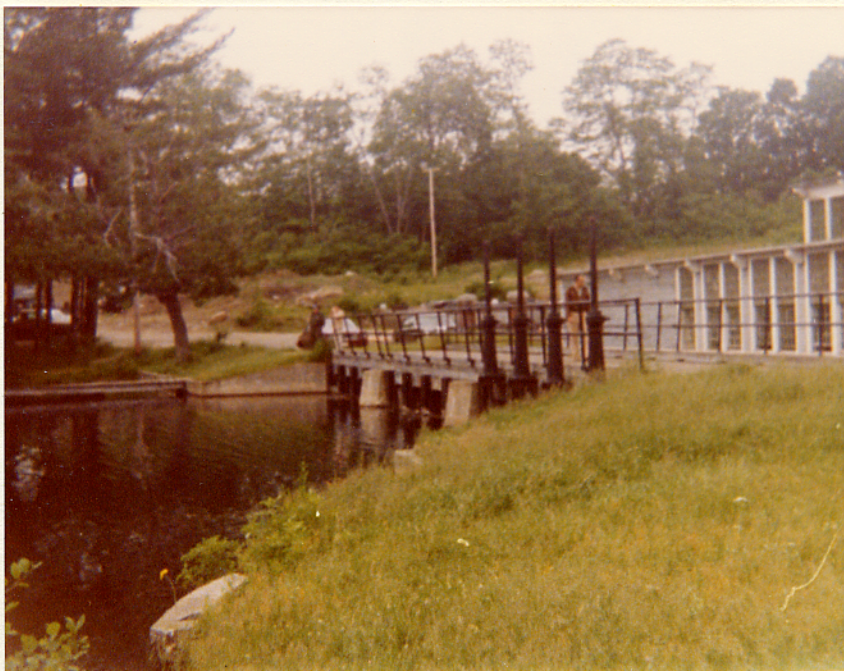
6

c. Visual Observations. Space between top of stoplogs (and gates) and underside of bridge could plug easily. Some growth and debris was noted on the downstream side of the structure. Overflow of the right abutment would flow onto Main Street.

Upstream View of Spillway from Right Bank

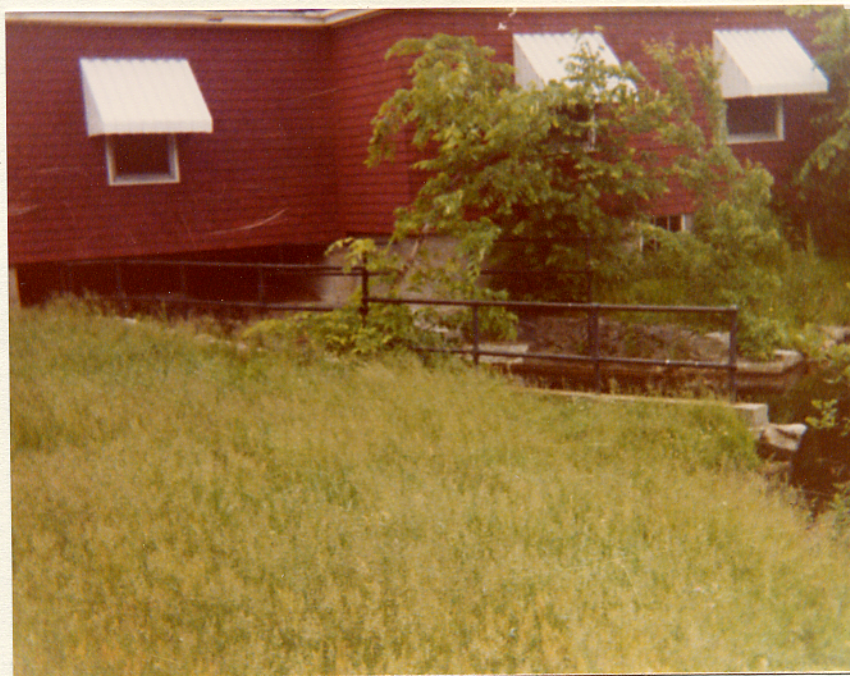
7

c. Appurtenant Structures. The only observable appurtenant structure is a closed and abandoned inlet to what was once a mill building adjacent to the right abutment. This structure appears sound and is of no consequence.

Abandoned Inlet to Mill Building

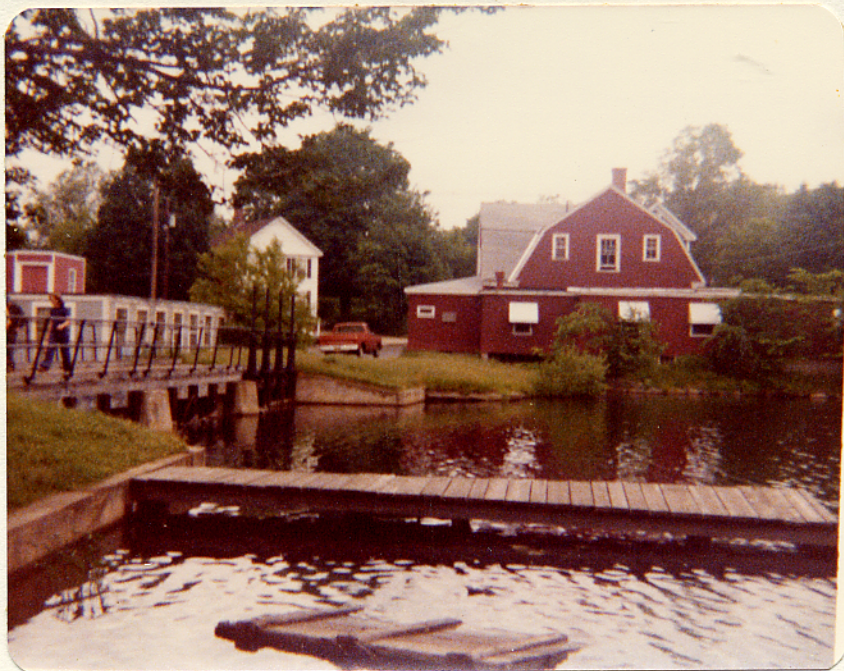
2

Upstream View of Dam from Left Bank

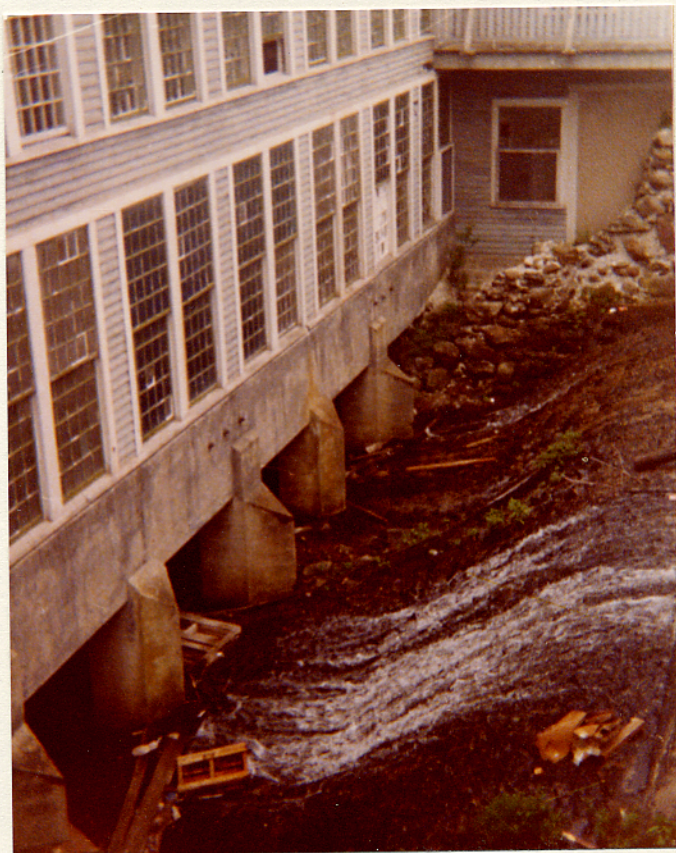
3

e. Downstream Channel. The spillway discharges directly under an industrial building, runs through a narrow channel between other industrial buildings, and under a highway bridge before discharging into a natural watercourse. There are several homes on the banks of this watercourse.

Downstream View of Spillway from Bridge
